# OGLALA SIOUX OF PINE RIDGE RESERVATION HOUSING AUTHORITY TRIP REPORT

## Assessment of Mold and Moisture Conditions

### Final Report

July 12-16, 2004

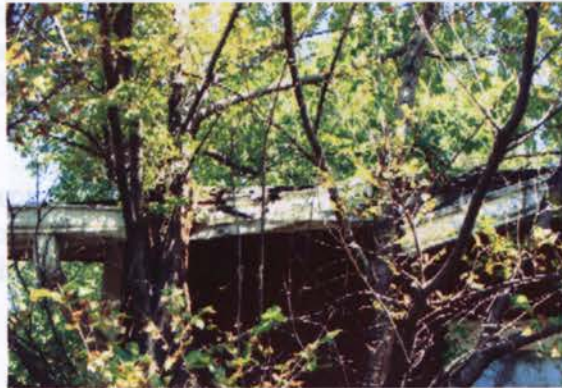
Site rainwater management was poor at all eight homes. Good rainwater management begins with good gutter and downspout systems. Many of the gutters were in poor condition from physical damage or from overgrowth (Figure 1).

Figure 1: Substantial damage to gutter from overgrown tree and brush.

3. Repair or replace damaged gutters. Ensure continued maintenance of gutters.
4. Overcrowding plays a fundamental role in each of the remaining four problems above, by amplifying the problems. During the training session held Thursday, July 15<sup>th</sup>, members of the OSTC and HA emphasized the need to mitigate overcrowding. Increasing the housing supply through construction is ideal and has started to take place at Wounded Knee.

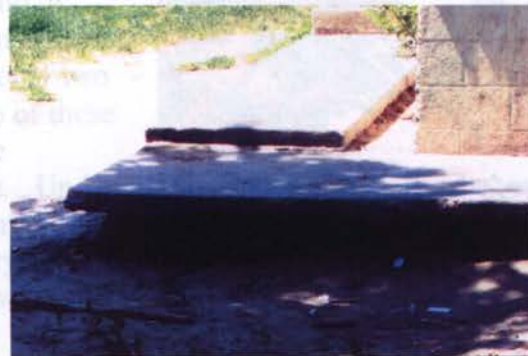
Most of the homes had walkways partially surrounding them (Figure 2). One home under construction, visited but not inspected, had a new walkway around the building. The soil that was once at the level of the sidewalk had eroded and now the sidewalk appeared suspended above the soil grade. There was very little lawn or other plant growth on the soil surface around these homes. This was because of; 1) local soil that did not easily support plant growth, 2) human traffic around the homes and 3) erosion by rainwater. If the soil between the walkway and the home erodes, it forms a basin that hinders water drainage away from the foundation.

Figure 2: Erosion of soil around the home, due to surface flow of rainwater.

1. Improve the rainwater control for the building site. This may involve occasional regrading and replacement of eroded topsoil, together with a plan for using a hardy plant cover for the soil. Also include the placement of culverts on the surface or drain tiles beneath the surface to prevent the erosion taking place. The erosion leads to local soil depressions near the building that capture rainwater and lead to water leaks and mold growth at the foundation.

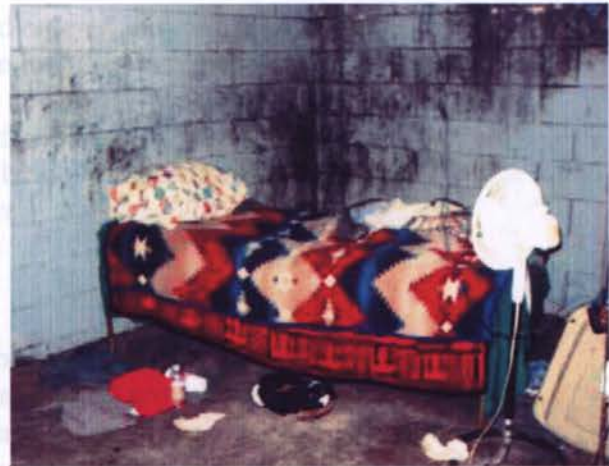
Figure 3 shows a bedroom located in a basement room. The water problem and consequent mold growth on the wall of this room is evident in the photograph.

**Figure 3.** A basement corner used as a bedroom, a consequence of overcrowding.

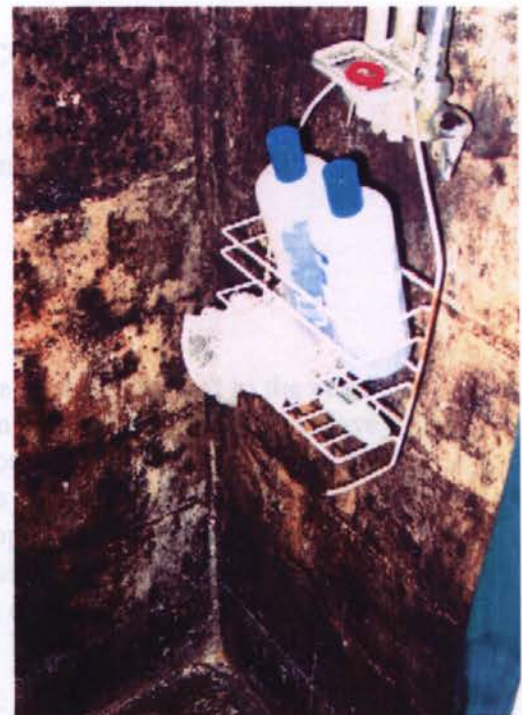
The bathrooms in all the homes had some mold growth at the tub surround, between the tub and toilet, and on the bathroom ceiling. Major mold growth was found in basement shower units. Some 3 and 4-bedroom homes were designed and built with small (measuring only two feet in width) showers in the basement. In two of these homes the inside surfaces were painted concrete masonry. There was no mechanical ventilation. Under normal use, the painted surface adsorbs considerable quantities of water and the drying process is very slow. The mold growth on these surfaces was extensive on the floors, ceilings, and walls (Figure 4).

**Figure 4.** Basement shower with surfaces of painted concrete block.

6. Solve mold problems in basement showers by cleaning (as described above) and installing proper shower surrounds (fiberglass resin or PVC) on the block walls. Clean and repaint the floor and ceiling surfaces using an industrial coating, such as epoxy paint. Place a lamp in the shower—infrared heat reduces moisture on the surface and UV light inhibits mold growth. Install an effective vent fan.

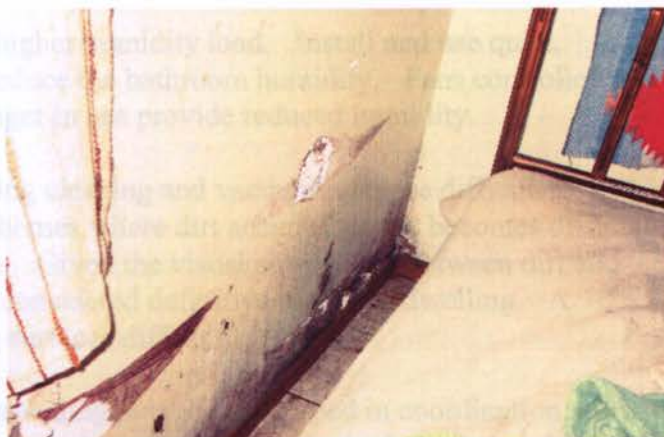
**Figure 5. Mold growth due to cold surfaces (corner condition) and blocked surfaces. The bed was moved away from the wall in order to take the photo.**

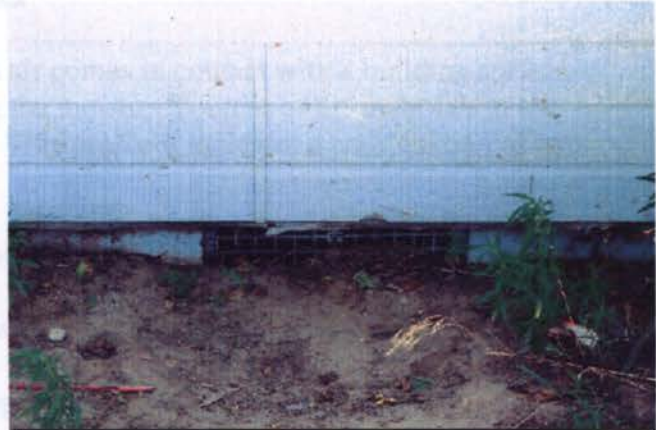
Since the 1940s, vents have been recommended as a method of moisture control in crawl spaces. Lately, the effectiveness of crawl space vents has been questioned. The ability of vents to dry the wet crawl spaces is limited by the amount of air that moves through the vents, and by the difference in humidity content between the incoming and outgoing air. That amount is generally quite small. On the other hand, vent openings are often installed at or near grade, and in this location, water can enter through the openings (Figure 6), rendering them not ineffective. More water can enter through the vent than can be dried by air moving through the vent.

**Figure 6.** The opening between the crawl space and outdoors has a greater potential for water entry than the potential for drying. The term “vent” is inappropriate in this case.

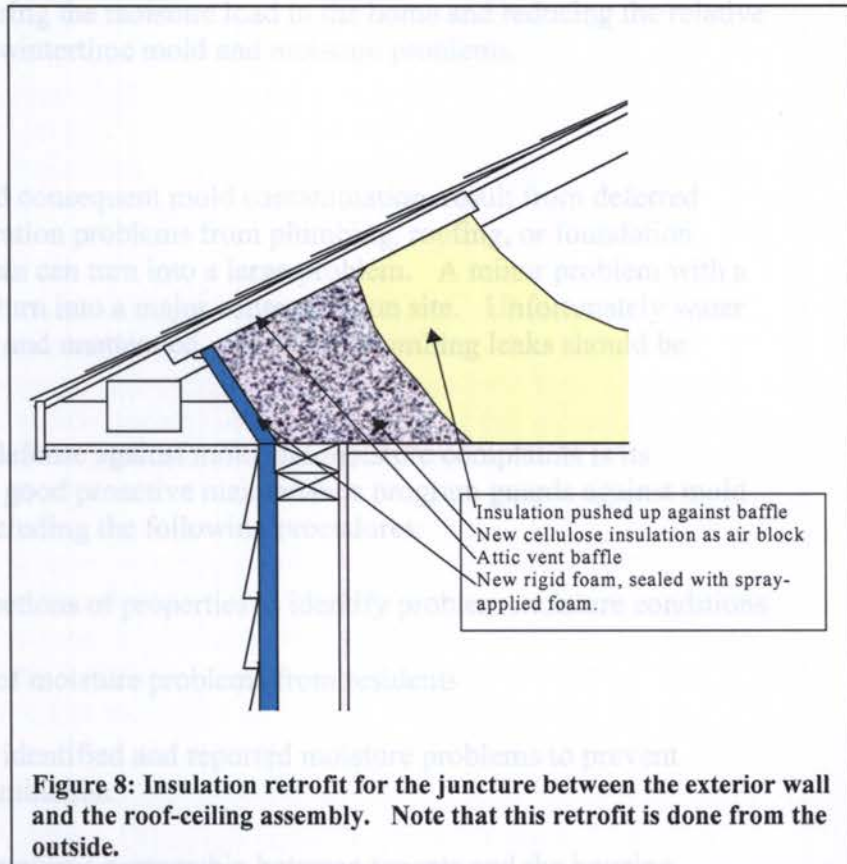
**Figure 8: Insulation retrofit for the juncture between the exterior wall and the roof-ceiling assembly. Note that this retrofit is done from the outside.**

especially in homes with low-pitch roofs, but with batt insulation, use special pusher sticks to get the insulation out to the edge. With loose fill insulation, prepare the outside edge correctly so that it is packed with insulation.

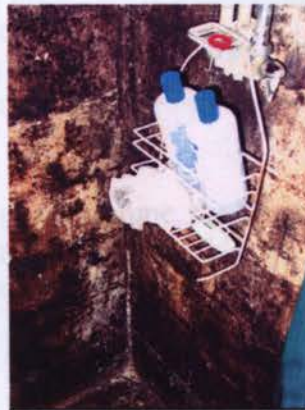
**Figure 2 – Mold in the basement shower.**

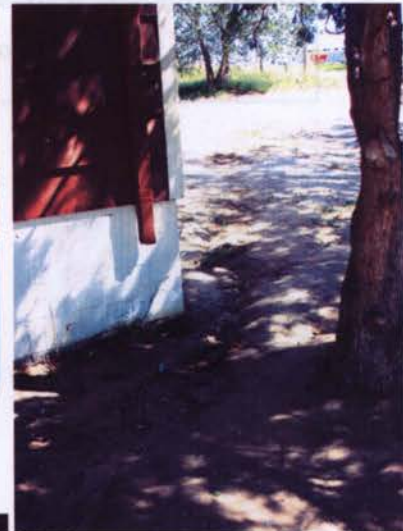
**Management:** The site sloped back to front. Erosion patterns showed that rainwater flowed along the house from the back to the front yard (Figure 3). Several gutter problems existed, including missing splash blocks, downspouts, and leaders (Figure 3). The front walk formed a dam allowing rainwater to pool against the foundation (Figure 4).

**Figure 3 – Missing leader. Note erosion pattern.**

1. Grade the yard and create swales to divert groundwater away from the foundation while it drains, following the natural slope, from the rear of the home toward the front of the house.
2. Repair damaged gutters and replace missing downspouts, leaders, and splash blocks.
3. Install a through-the-wall exhaust fan in the basement bathroom. Use controls to operate the fan for a specified time period after each shower.
4. After cleaning the mold off the shower walls, install a cleanable hard surfaced shower surround.
5. Inspect and repair the flashing around the chimney vent to prevent roof leaks.

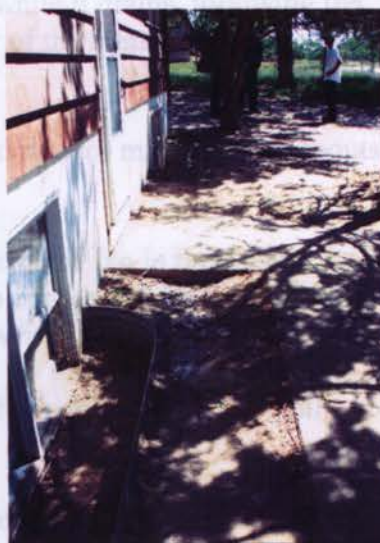
**Figure 4 - Sidewalk "dam".**

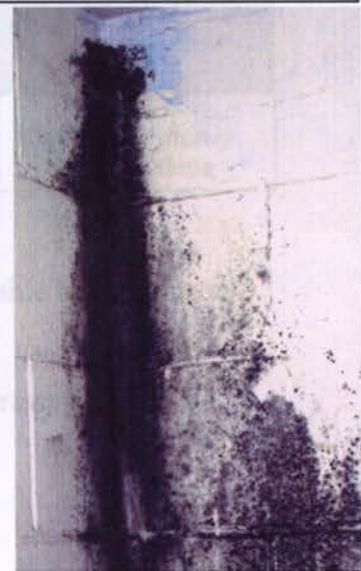
**Figure 5 - Mold in the basement corner**

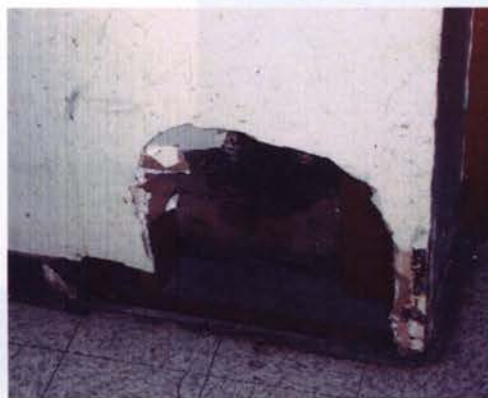
Figure 6 - Mold on the wall near the furnace.

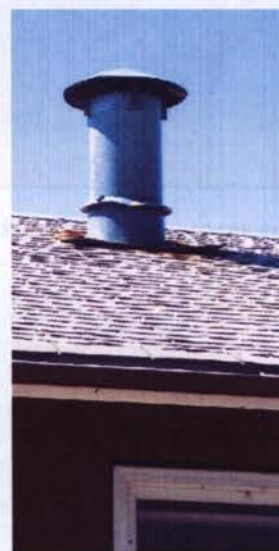
Figure 7- Chimney vent and flashing

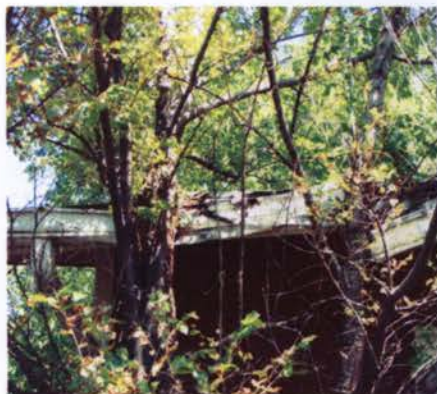
**Figure 2 – Trees causing gutter and roof damage.**

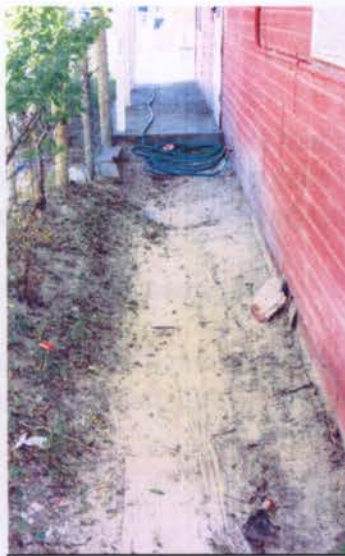
**Figure 3: Site drainage**

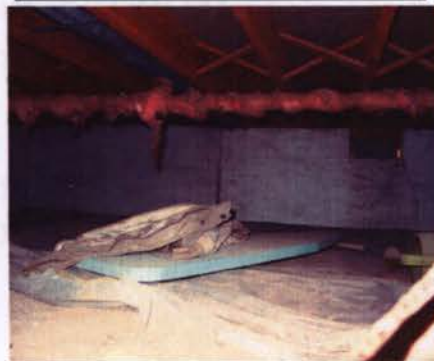
**Figure 4: Crawl space conditions**

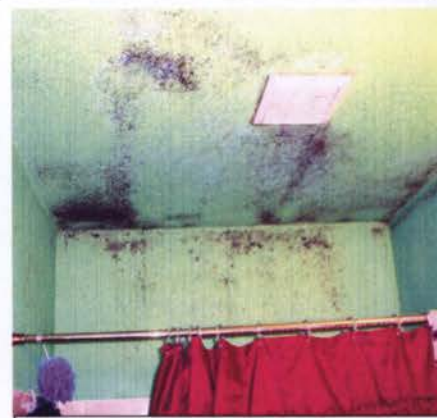
**Figure 5: Bathroom mold.**

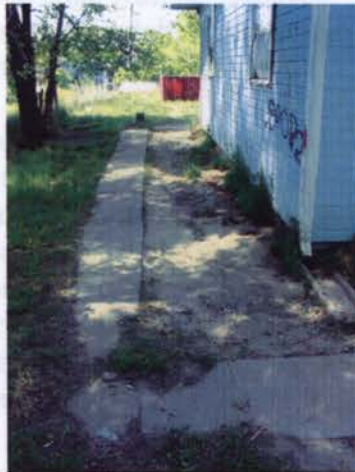
**Figure 2: Sidewalk water dam**

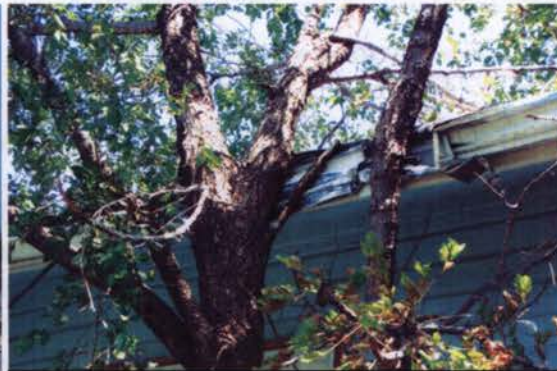
**Figure 3: Destruction of gutter by tree**

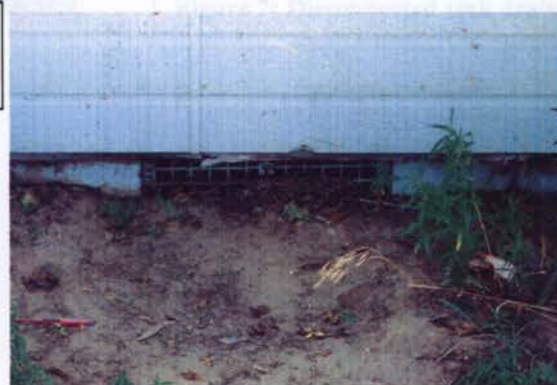
**Figure 4: Crawl space vent.****Site Drainage and Rainwater Management:**

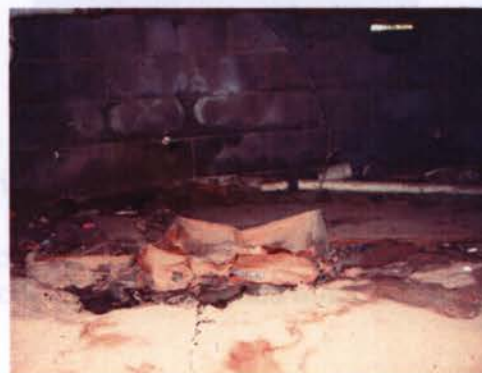
**Crawl Space Conditions:** There were signs of water intrusion into the crawl space (Figure 5). Water intrusion resulted from the concentration of rainwater against the foundation and from the vents. A drain pipe located in the crawl space was

**Figure 5: Wet crawl space.**

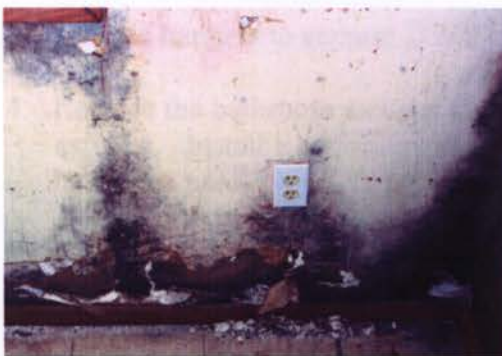
Condensation-based mold was severe in one bedroom and present in two other bedrooms. Minor surface mold was visible on the bathroom tub/shower surround. Other moisture problems were apparent.

Figure 8: Severe mold contamination in bedroom.

- Clean the contaminated surfaces and replacing drywall as necessary.

- Lower the relative humidity in the residence.
- Ensure adequate heat to the bedroom.
- Avoid placement of furniture against the exterior walls.

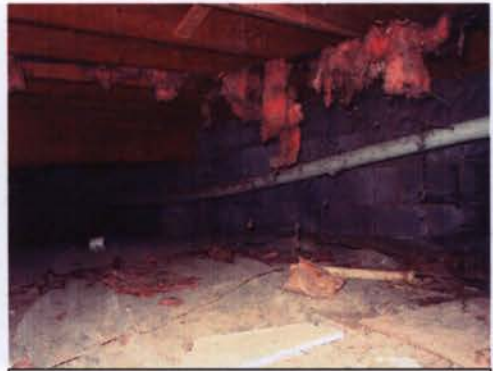
Figure 6: Unsupported drain pipe.

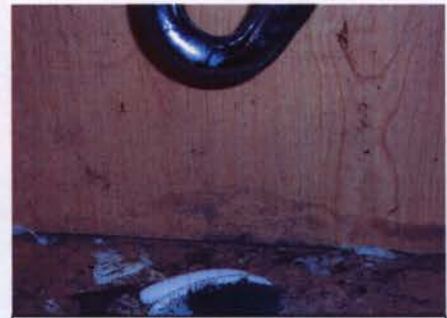
Figure 7: Disconnected sink drain

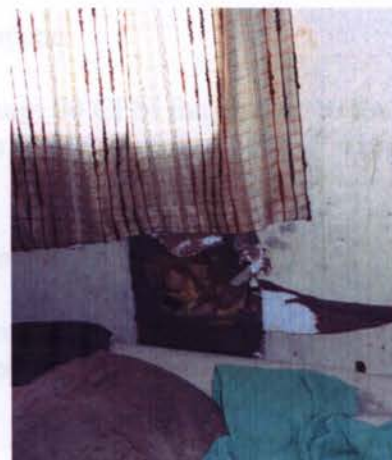
Figure 9: Water damage below window.

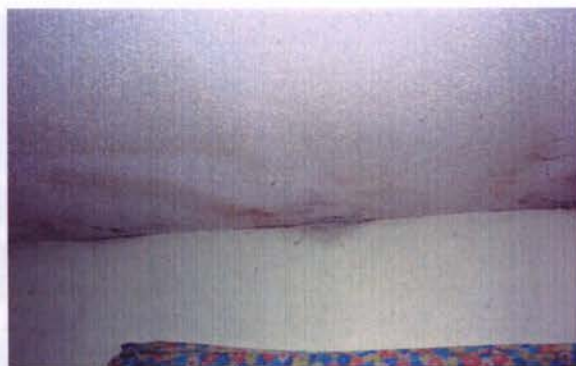
Figure 10: Moisture at wall/ceiling juncture

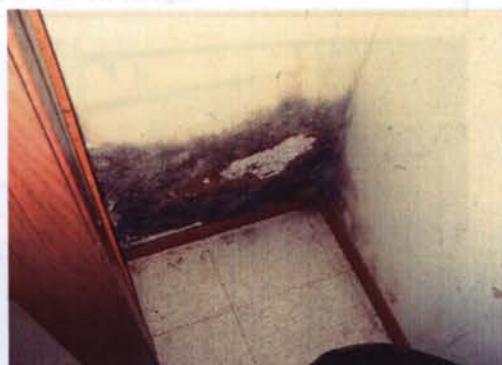
Figure 11: Mold contamination in closet

9. Install louvered closet doors and maintain an air space on exterior walls inside the bedroom closets.

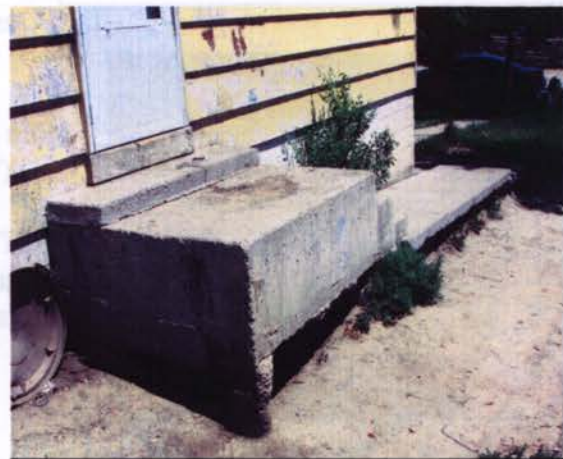
Figure 2: Soil erosion by foundation at the stairs

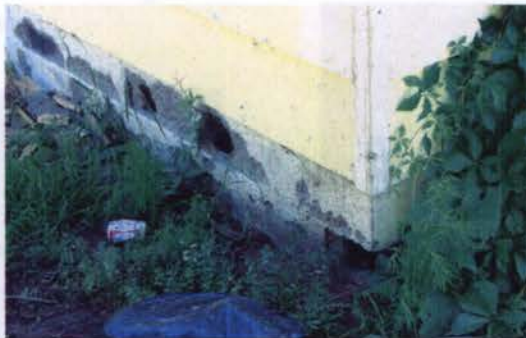
Figure 3: Water-damaged block foundation

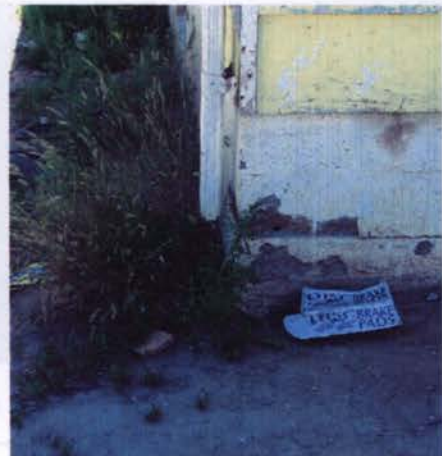
Figure 4: Missing leader and foundation erosion

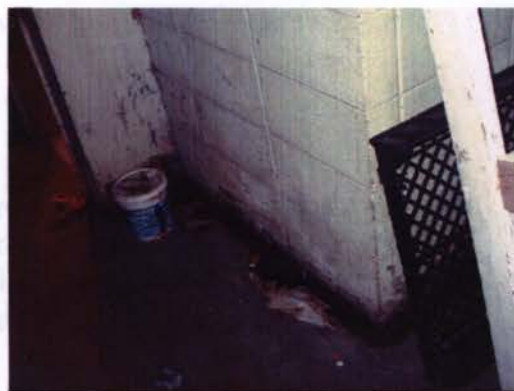
Figure 5: Water damage at base of basement wall.

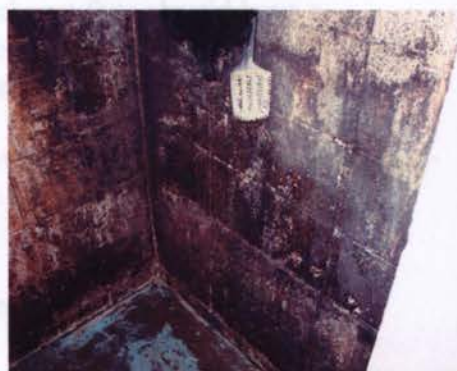
Figure 6: Mold in basement shower stall.

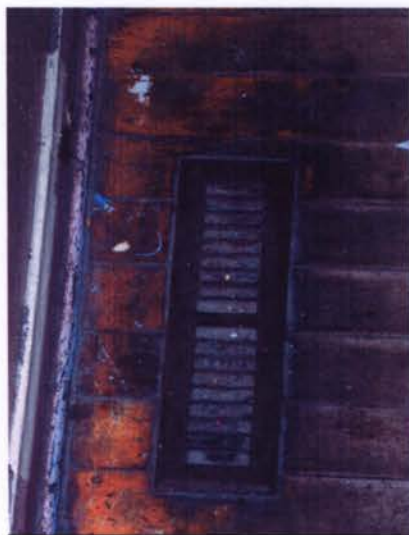
**Mechanical:** Grilles on the forced air supply ducts were clogged with dust and debris (Figure 8). This likely inhibited even heating throughout the home.

Figure 8: Supply vent clogged with dust and debris

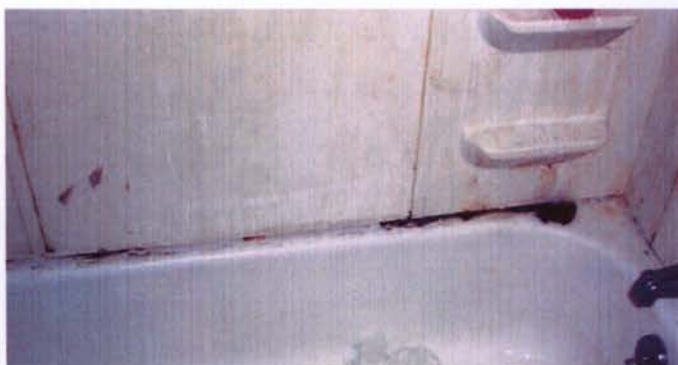
Figure 7: Mold on tub surround in first floor bathroom

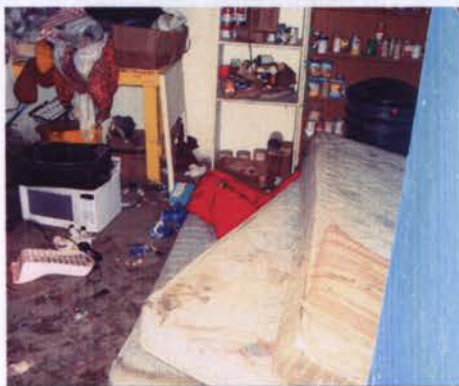
**Basement/Crawl Space:** Considerable clutter made the inspection of the basement difficult (Figure 3). The basement was subdivided into bedrooms that were not accessible for inspection. The drain for the washing machine was improperly installed, routed to the clean-out access for the main sewer line, thus containing no trap for the prevention of sewer gas (Figure 4). There were water stains and potential mold on the walls in the location of the washing machine.

Figure 3 – Basement clutter

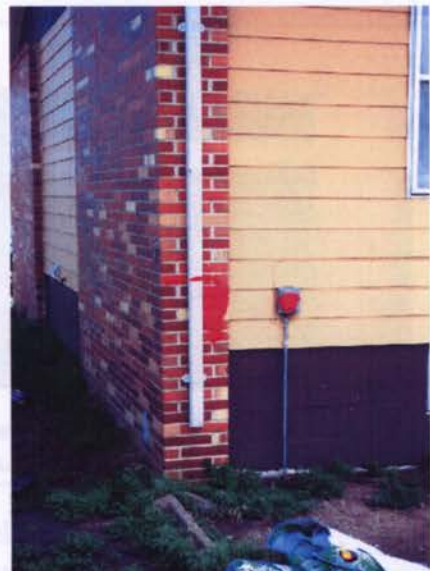
Figure 2: Missing leader on downspout.

1. Repair damaged gutters and replace missing downspouts, leaders, and splash blocks.
2. Install an exhaust fan in the bathroom, with a minimum 80 CFM capacity and ducted to the exterior. Install controls on the fans that allow for delayed shut-off following bathroom use. Clean up existing mold in the bathroom with detergent and water.
3. Remove clutter from the basement. Provide a proper drain for the washing machine.
4. Clean the mold and deteriorated drywall from below the kitchen sink.

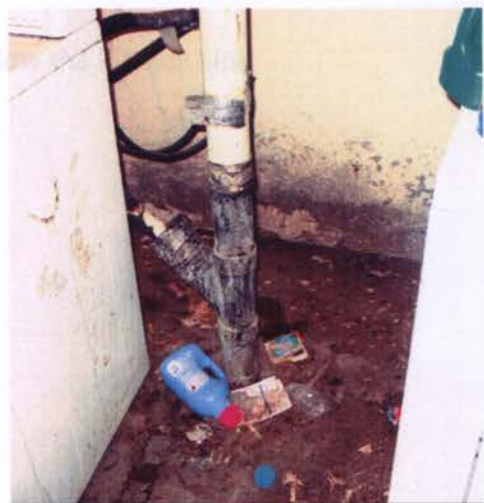
Figure 4: Improper drain on washer, moisture damage on basement wall

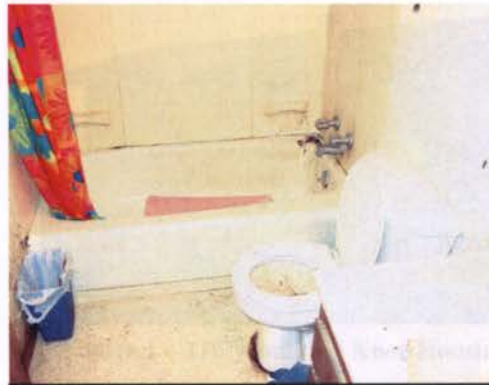
Figure 5: Bathroom mold

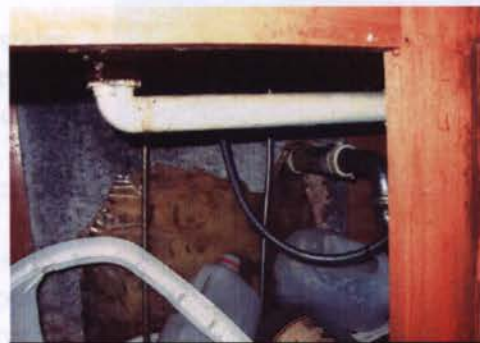
Figure 6: Deterioration under kitchen sink.

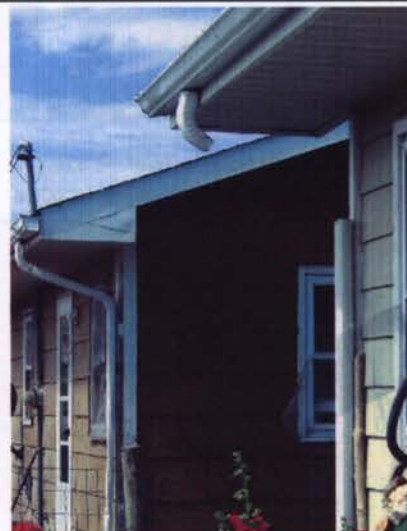
**Site Drainage and Rainwater Management:** Site drainage was generally good, with some grade away from the foundation. There were some localized depressions beside the foundation. The gutter system was missing downspouts and leaders at several locations (Figure 2). A brick border for foundation plantings served to trap rainwater against the foundation, threatening bulk water leakage into the window wells (Figure 3). This situation is critical in cases where downspouts and leaders are missing, thus concentrating rainwater in these locations.

Figure 2: Missing gutter connection to downspout.

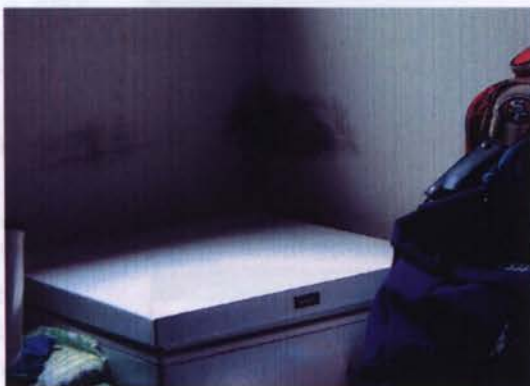
**Basement:** Much of the basement had been recently been drywalled, painted, and appeared in good condition. Residents indicated that water entry had been a problem. One corner of the basement appeared wet and moldy (Figure 4).

Figure 4: Mold in basement corner.

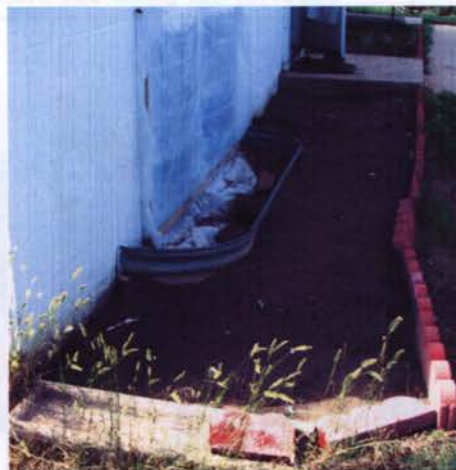
Figure 3: Brick border serving as a dam around foundation.

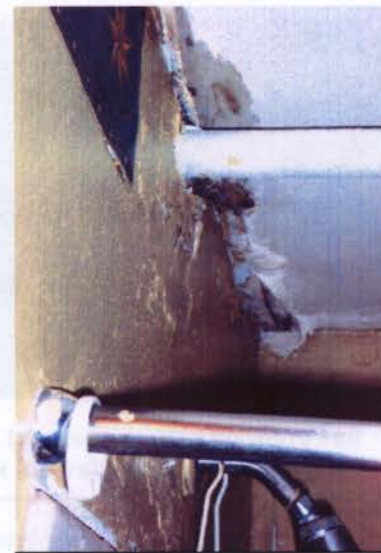
**Figure 5: Water damage above basement shower.**

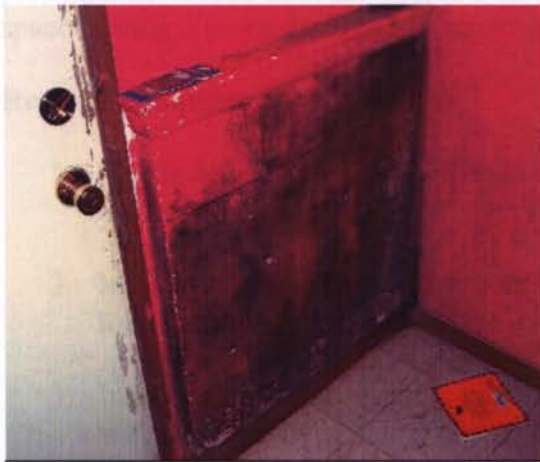
**Figure 6: Mold on stair landing**

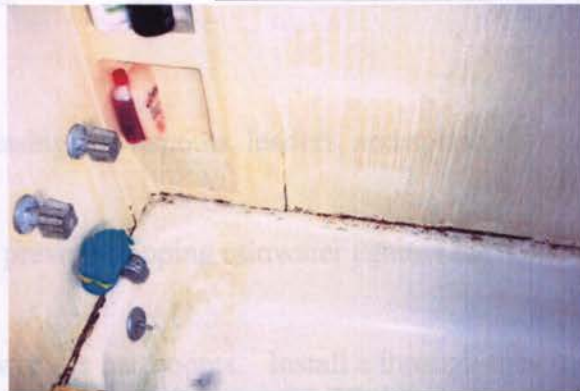
**First Floor Bathroom:** The tub surround was stained and moldy at the base (Figure 7). There was mold contamination on the ceiling above the shower (Figure 8). The exhaust fan in the bathroom was weak.

**Figure 7: Stained and moldy tub surround**

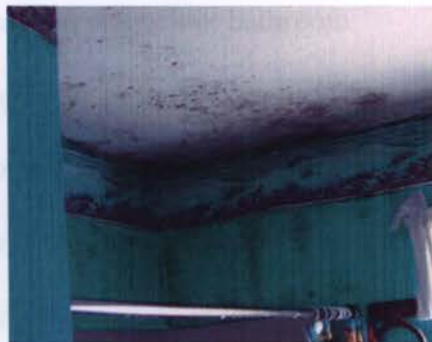
**Figure 8: Moldy ceiling**

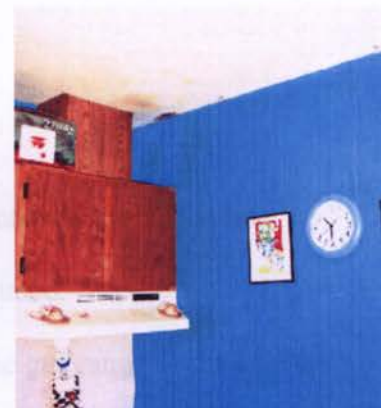
**Kitchen:** Most of the kitchen surfaces were free of moisture problems, except on the wall and ceiling above the gas stove (Figure 9). Both cooking and the gas combustion generate significant moisture. The range hood at this house exhibited weak flow

**Figure 9: Condensation above stove.**

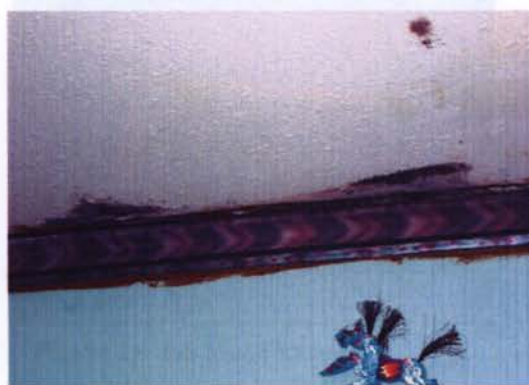
Figure 10: Condensation moisture and mold at the wall/ceiling juncture.

10. Discontinue or limit winter use of the humidifier.

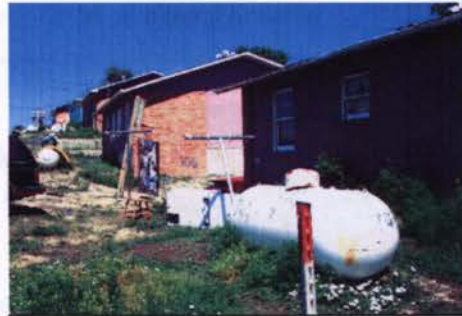
**Site Drainage and Rainwater Management:** The house was positioned in the middle of a block that was built on a hill, so that each site drained to the one below (Figure 2). There was good site drainage at the front and downhill sides of the site. At the uphill side of the house, however, the drainage pattern has lead to serious erosion problems (Figure 3).

Figure 2: Site context

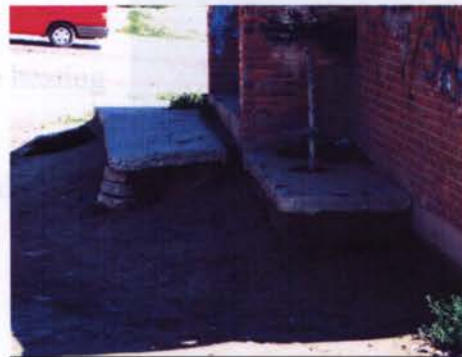
Figure 3: Erosion on uphill side of house

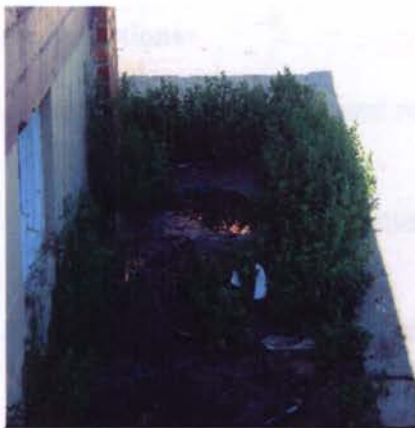
The house was missing all downspouts. This had resulted in rainwater concentrating around the foundation (Figure 4). A concrete sidewalk magnified this problem by trapping water next to the foundation (Figure 5).

Figure 5: Water trapped next to foundation by sidewalk.

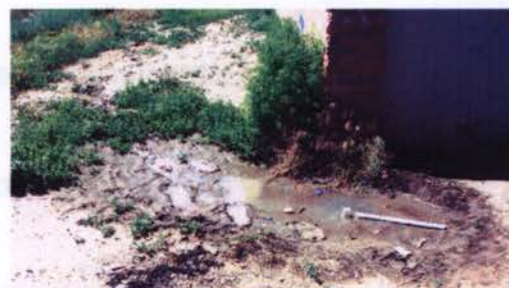
Figure 4: Rainwater concentration

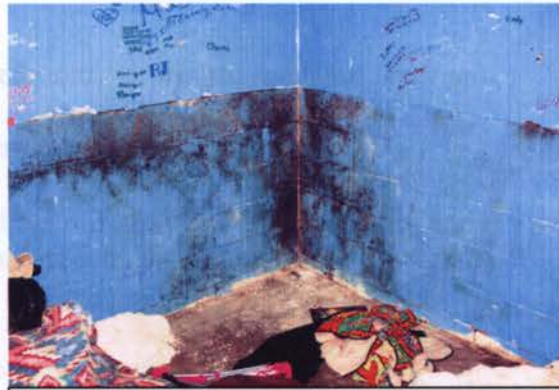
**Basement:** The basement was finished with drywall halfway down the walls and was subdivided into sleeping spaces. This fact, along with excessive clutter, made the space difficult to inspect. There was clear evidence of mold growth on the lower, exposed block walls (Figure 6). Residents claimed that the basement leaked everywhere.

Figure 6: Mold on basement walls.

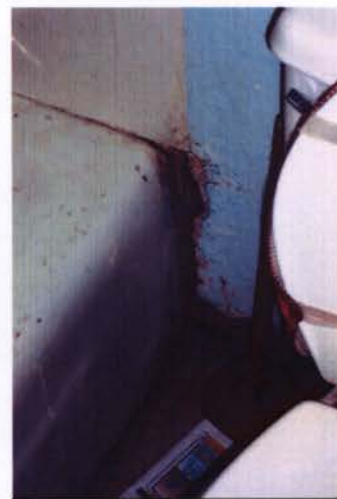
Figure 7: Bathroom moisture damage

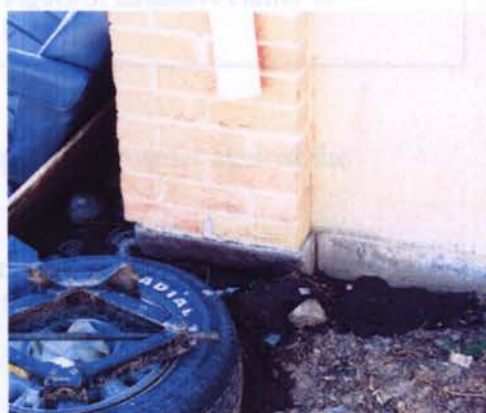
Figure 2: Missing leader and foundation wetness

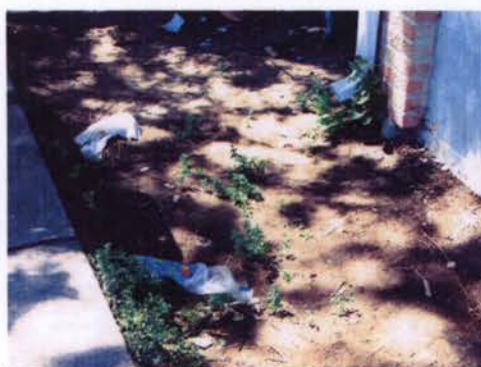
Figure 3: Surrounding walkway and missing leader.

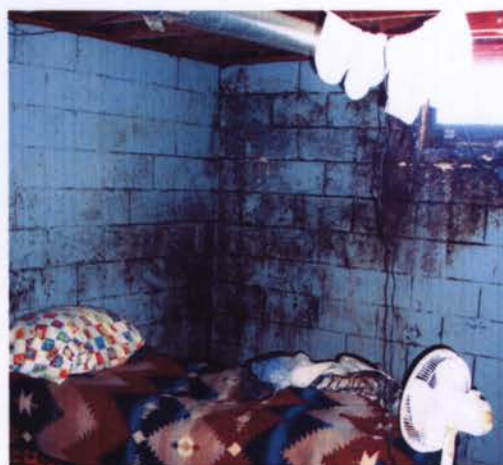
The basement had been subdivided into numerous bedrooms. There was considerable clutter preventing complete inspection. There were signs of moisture entry into the basement. Signs of mold were visible as well (Figure 4).

Figure 4: Mold on basement bedroom walls and signs of moisture.

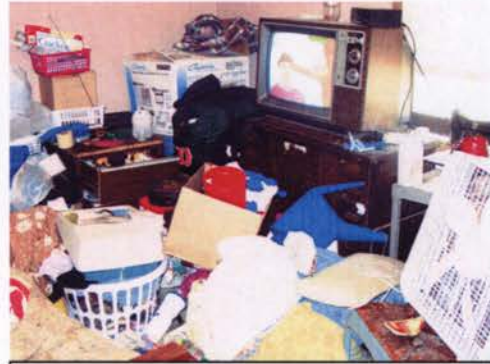
**Figure 5: Excessive clutter in bedroom.**
